# STOCK ASSESS

A PIPE DATA FIELD SERVICE

**THE ONSITE SOLUTION  
FOR EFFICIENTLY  
ASSESSING OR  
RE-USING STOCK**

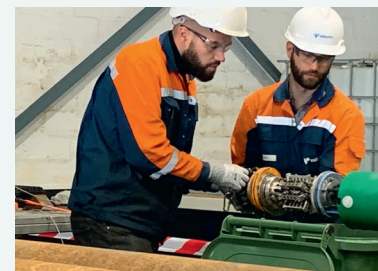
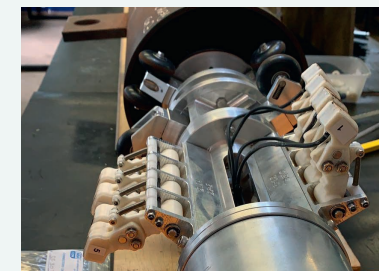
Leveraging the In-Pipe Rover, a portable inspection device, the service provides full real-time defect and wall thickness maps to evaluate pipe condition. The inspection is carried out directly at the operator's yard site.

Equipped with **Ultrasound (UT) and Eddy Current Testing (ET) technologies**, the In-Pipe Rover

can be run on the rig deck or in the yard.
