STOCK ASSESS

A PIPE DATA FIELD SERVICE

**THE ONSITE SOLUTION
FOR EFFICIENTLY
ASSESSING OR
RE-USING STOCK**

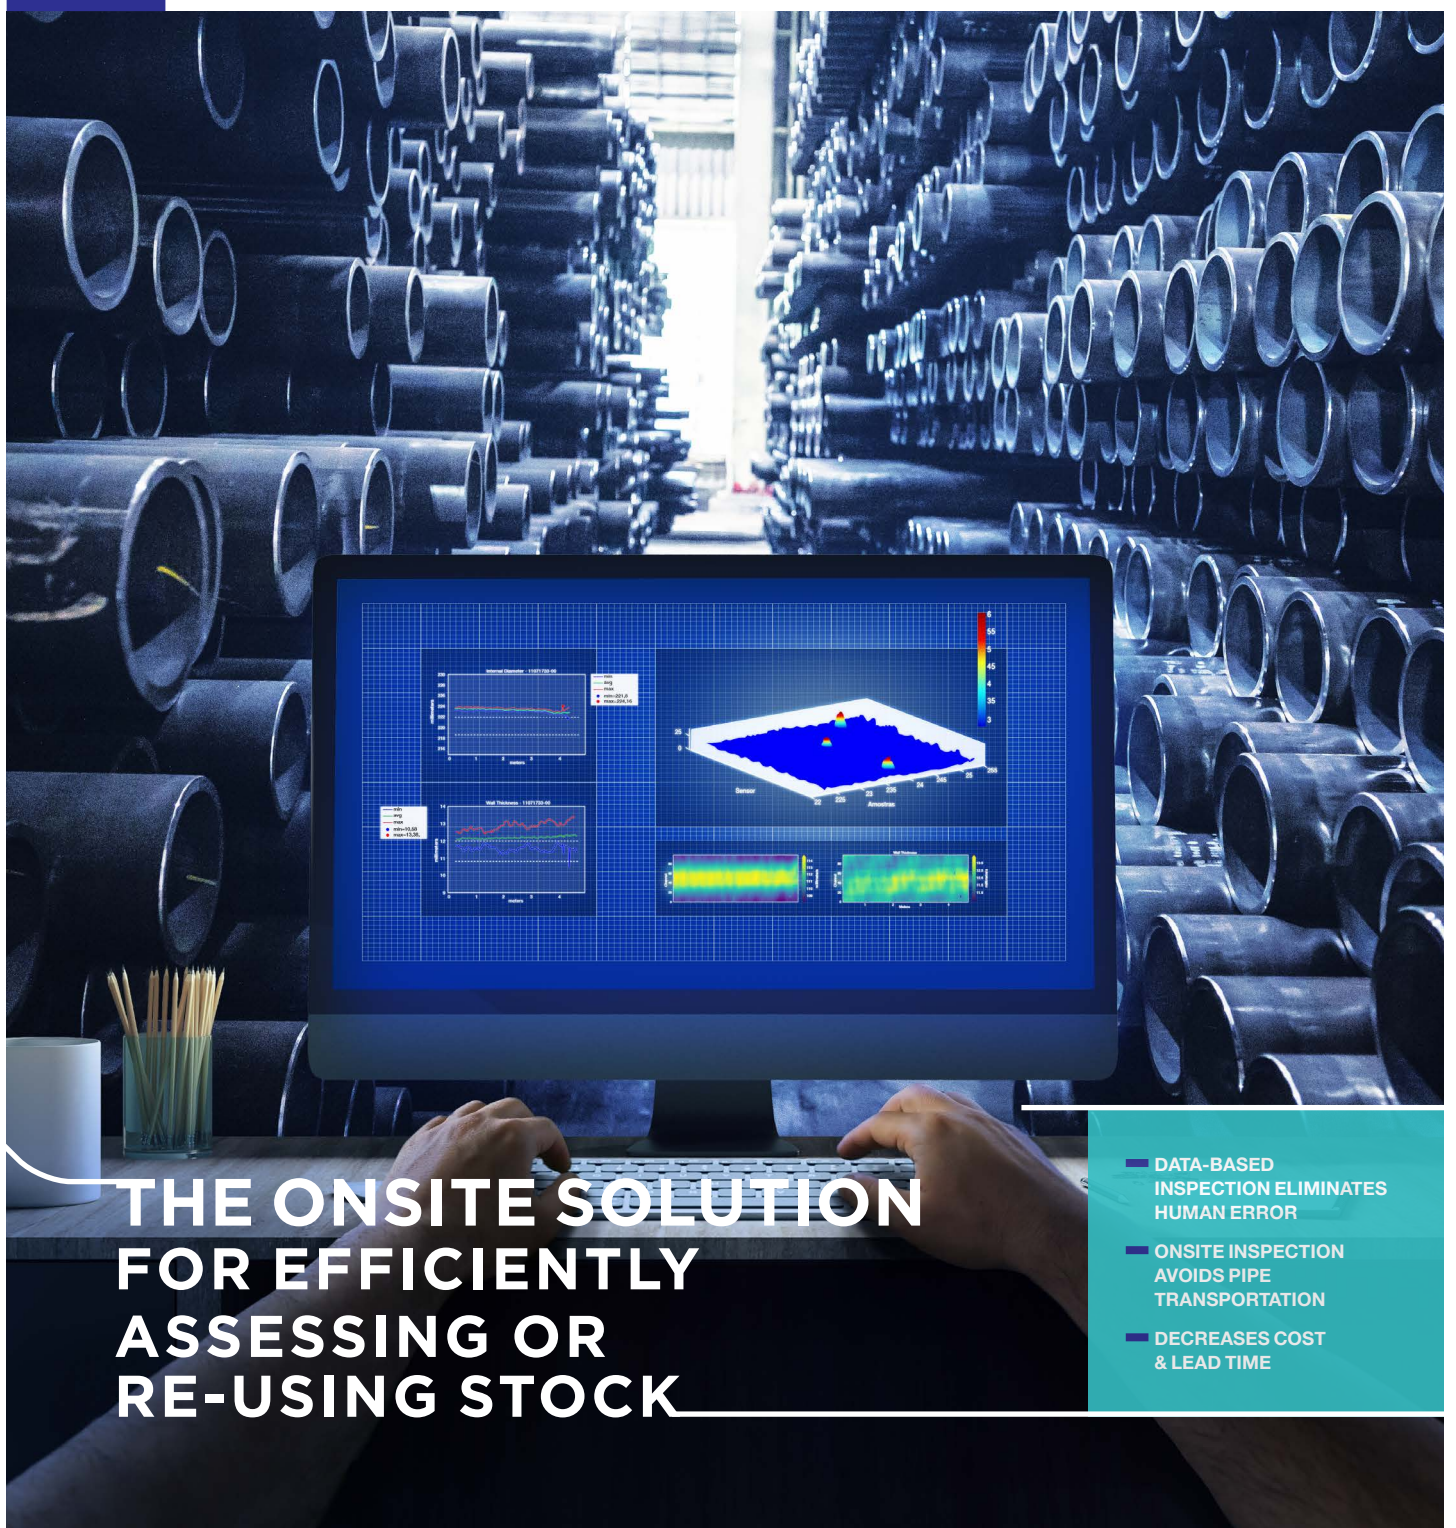
IN-PIPE ROVER:
A PORTABLE LOGGING
DEVICE USING EITHER
ULTRASOUND (UT) OR
EDDY CURRENT TESTING
(ET) TECHNOLOGY

Leveraging the In-Pipe Rover, a portable inspection device, the service provides full real-time defect and wall thickness maps to evaluate pipe condition. The inspection is carried out directly at the operator's yard site.

Equipped with **Ultrasound (UT) and Eddy Current Testing (ET) technologies**, the In-Pipe Rover

can be run on the rig deck or in the yard.

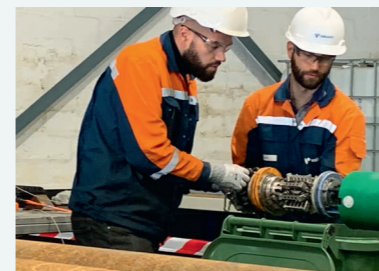
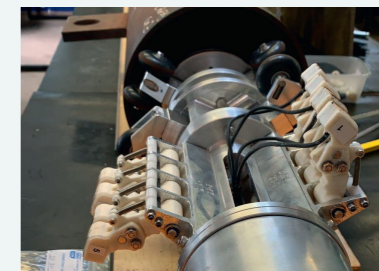
ENSURING INTEGRITY OF 7-YEAR STOCK

An IOC operating in Brazil needed ~30-40 joints 14" casing at the bottom of the string inside a salt dome. The section had a higher collapse risk than the rest, but there wasn't enough time to order new thicker 14" pipes.

Thanks to a visual inspection and an In-Pipe Rover with Ultrasound, the operator was able to check the 14" stock in its yard, which had been unused for 7 years. Of the 50 pipes inspected, 36 were accepted with full-length WT > 90% nominal. As a result, the operator was able to categorize pipes according to WT and ensure well integrity in the salt dome.
